PHASE I ENVIRONMENTAL SITE ASSESSMENT

HEADSTART BUILDING ST. PAUL ISLAND, ALASKA

National Oceanic and Atmospheric Administration
7600 Sand Point Way NE
Seattle, Washington 98115

October 19, 2005

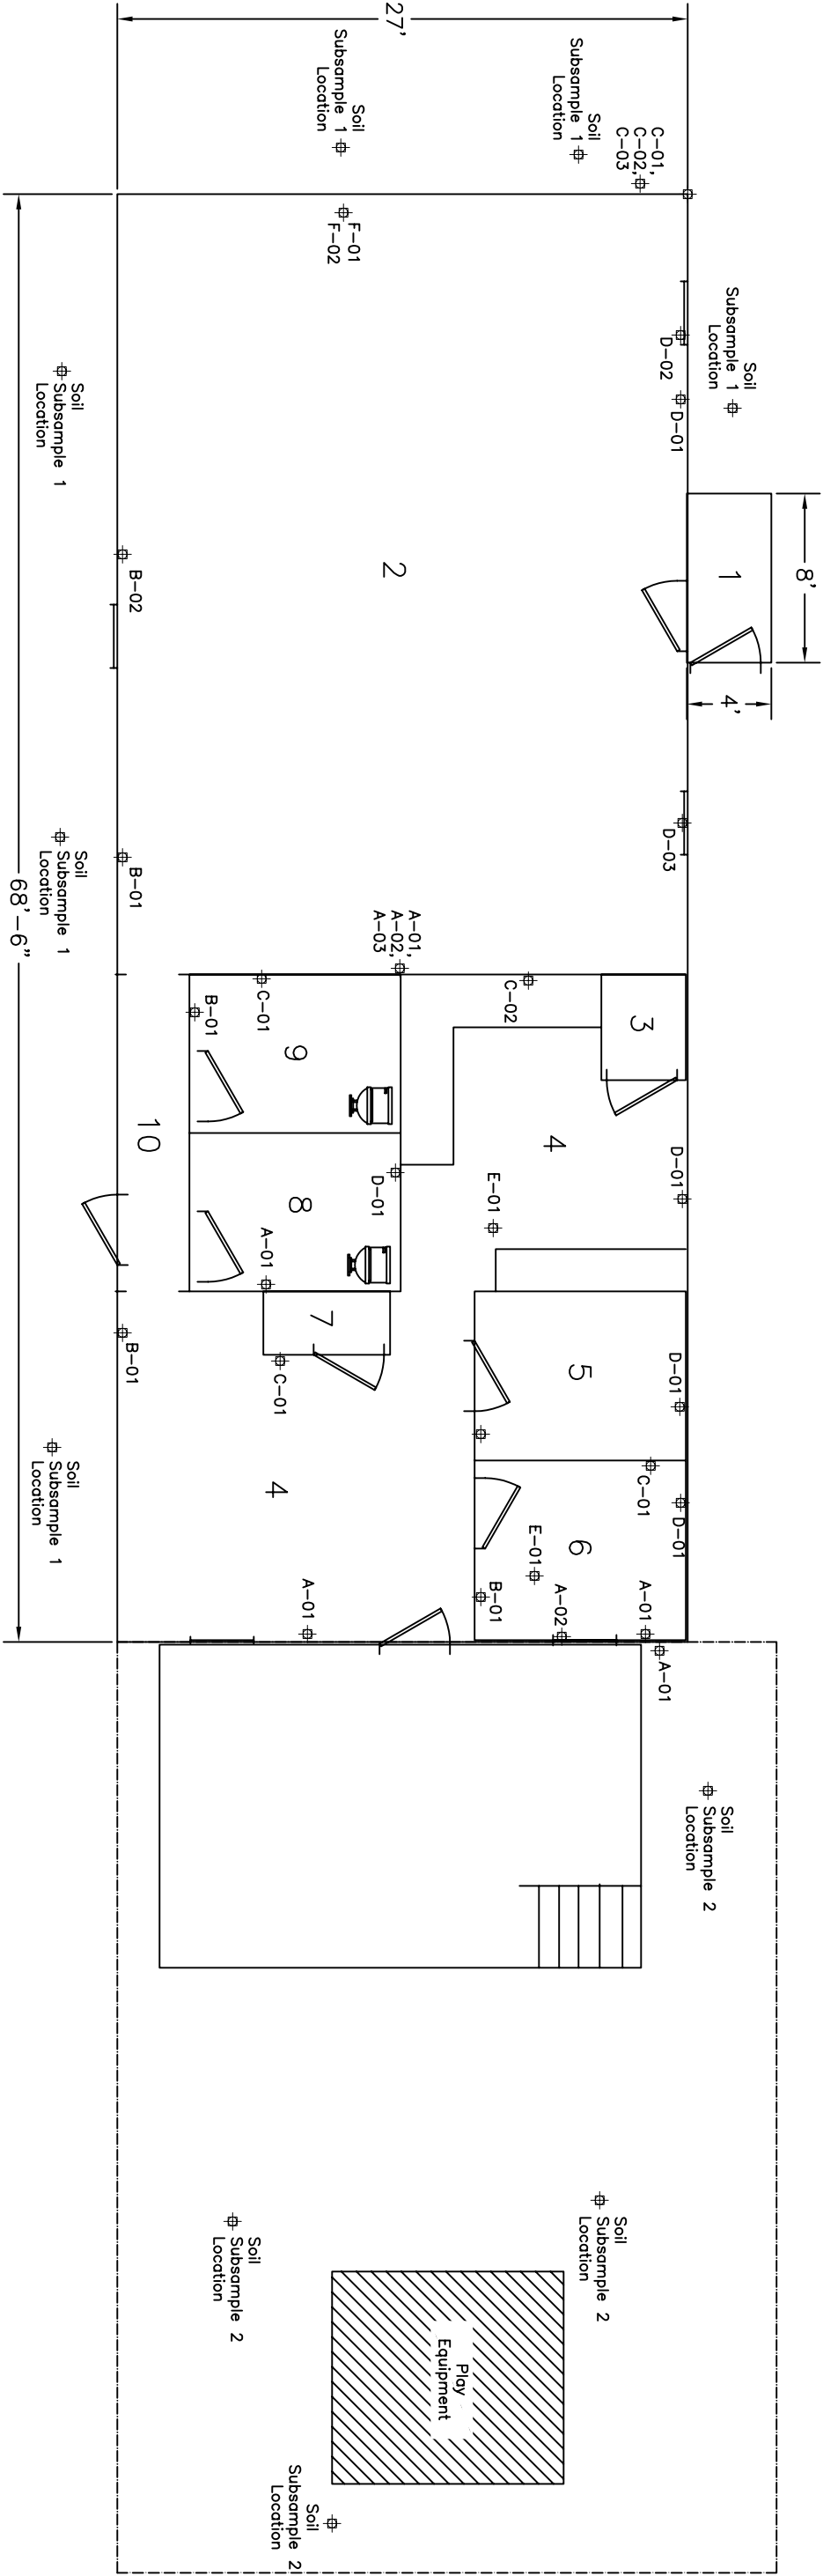
Figure 3 Room Equivalent & Lead Sample Locations, Main Floor Head Start Building Scale: 1/8" = 1'-0"

- Lead was found along the building’s drip line in surface soil above the ADEC residential cleanup level. Lead was not found in the playground area above the cleanup level.

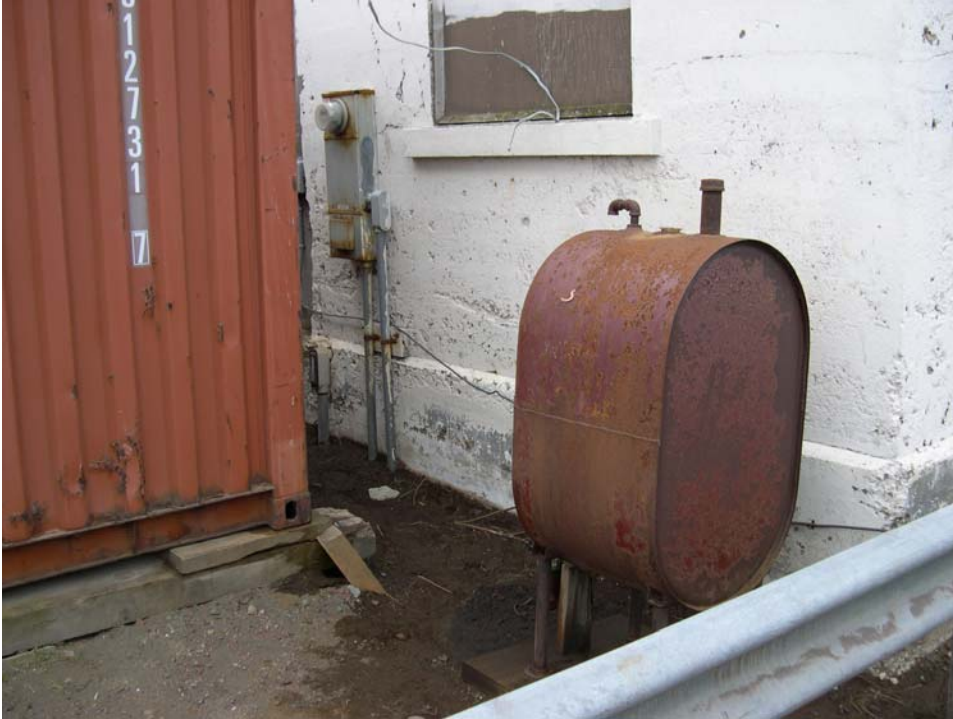
An aboveground storage tank (AST) was installed by the Aleut Community of St. Paul Island ("Tribal Government") outside the building; it is currently located at the north end of the building. NOAA observed a diesel fuel leak from the AST in 2004 and assisted the Tribal Government with removing an estimated 15 cubic yards of PCS and ultimately disposed of it at NOAA's permitted landspreading area at the National Weather Service station and as landfill cap material at Tract 42 (NOAA 2005f). Confirmation samples indicated the average DRO contamination in remaining site soil is 15,000 mg/kg. The AST was observed having a minor leak again during the building inspection on May 10, 2005. As

Photo 3. Headstart Building. Tribal Government Diesel AST. Facing Southeast. NOAA. May 2005

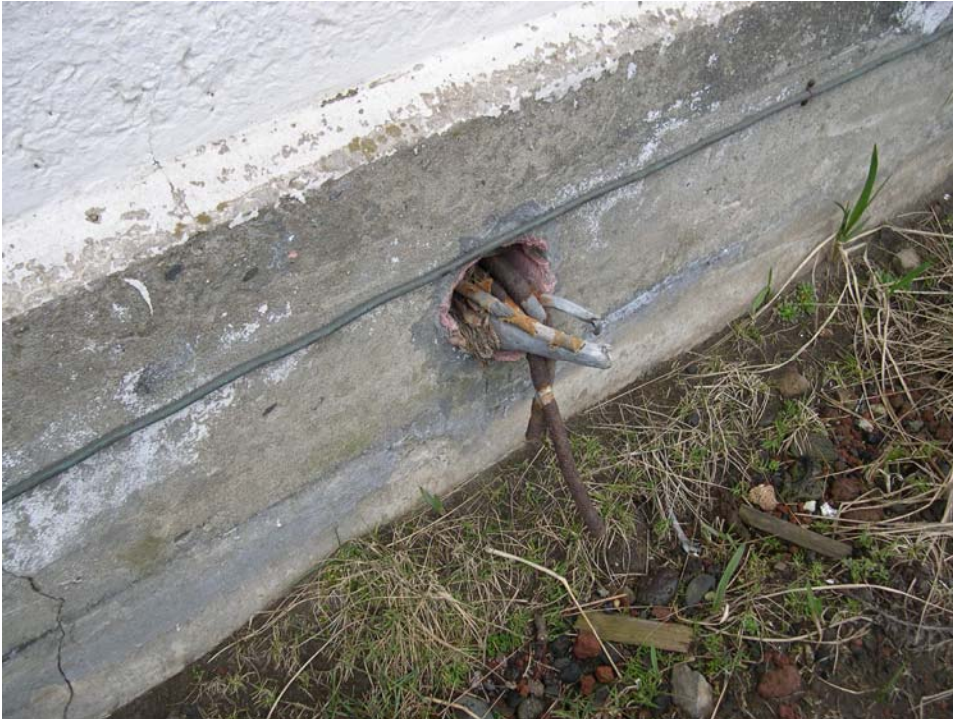
- Non-friable asbestos was encountered in a cement pipe conduit located within the concrete footing along the western side of the building exterior and potentially throughout the building’s

Photo 4. Headstart Building. Non-Friable ACM Conduit in Building Foundation. Facing Southeast. NOAA. May 2005

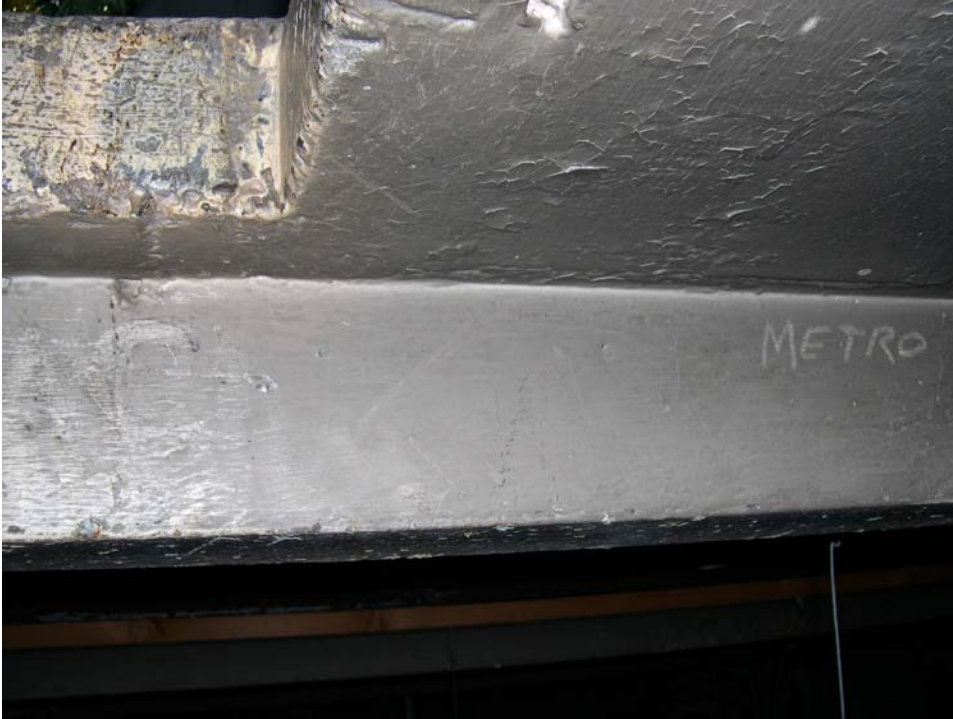
- Peeling LBP was encountered or suspected on the building interior (painted concrete walls, floors, and ceilings), though much of this LBP is covered by drywall and other building features functioning as enclosures that limit the release of LBP into the building environment. Peeling lead paint constitutes a lead-based paint hazard at a child-occupied facility under the Lead-Based Paint Hazard Reduction Act of 1992 (“Title X”, [Public Law {P.L.} 102-550]). LBP in fair condition was encountered on the building exterior (concrete walls). NOAA personnel verbally informed Mr. Baker of the Tribal Government on May 13, 2005 that its preliminary results indicated peeling LBP was present inside the Headstart Building

Photo 5. Headstart Building. Peeling LBP on Concrete Ceiling at Trap Door Opening to Mezzanine Level. NOAA. May 2005

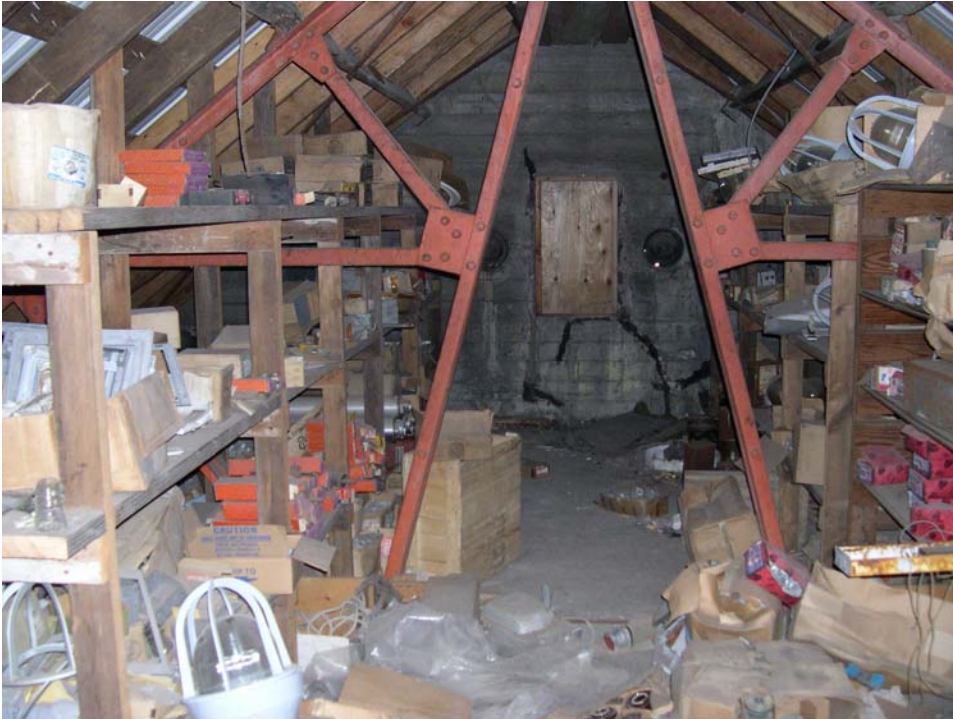
1-gallon cans of paint are also stored in the mezzanine level. LBP in fair condition was encountered on the mezzanine level. No ACBM was encountered on the mezzanine level.

Photo 6. Headstart Building. Mezzanine Level. Facing South. NOAA. May 2005

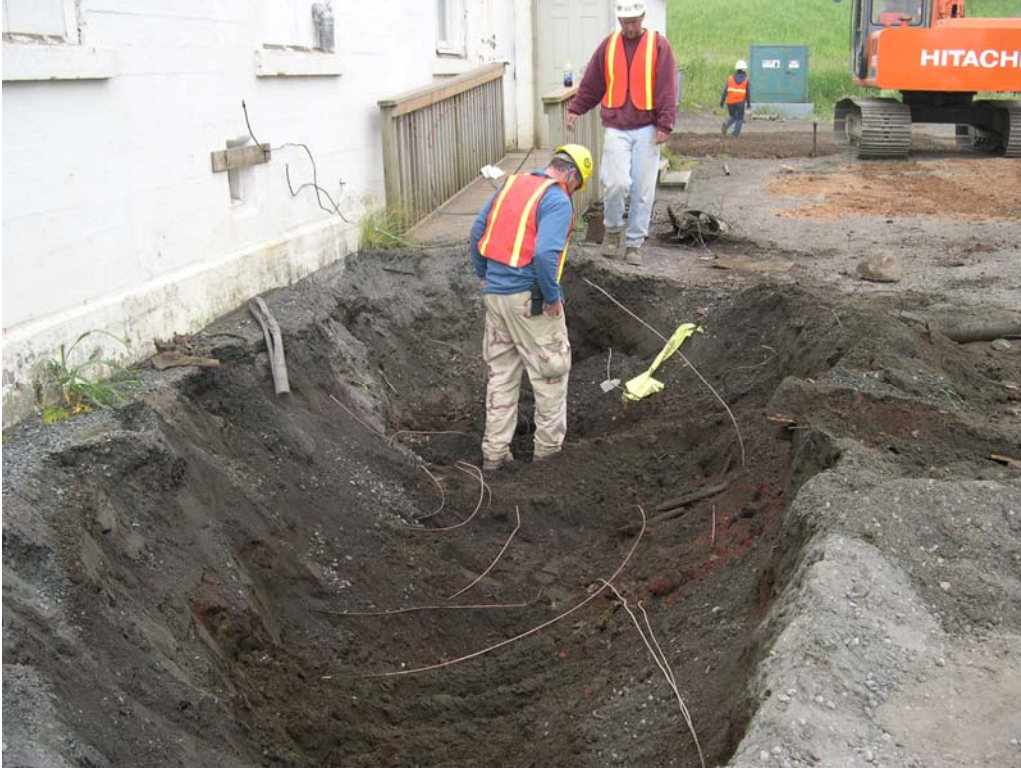
NOAA removed a UST and approximately 50 cubic yards of petroleum-contaminated soil (PCS). No further excavation was practicable due to the presence of buried utilities and the need to slope excavation sidewalls to prevent sloughing of soil beneath the building foundation (NOAA 2005e). One confirmation sample at 5 feet below ground surface exceeded the State of Alaska residential lead cleanup level of 400 milligrams per kilogram (mg/kg), with a concentration of 4,090 mg/kg lead. No other contaminants were identified at concentrations above the site-specific soil cleanup level of 2,500 mg/kg for diesel-range organics (DRO). ADEC approved NOAA's request for conditional closure of this soil contamination site (NOAA 2005e).

2003 Photograph. PCS Removal at Headstart Building. Facing North.
